PATIENCE PAYS OFF

Midland Engineering replaces the copper roofs on the Nebraska State Capitol

by **Ashley St. John**

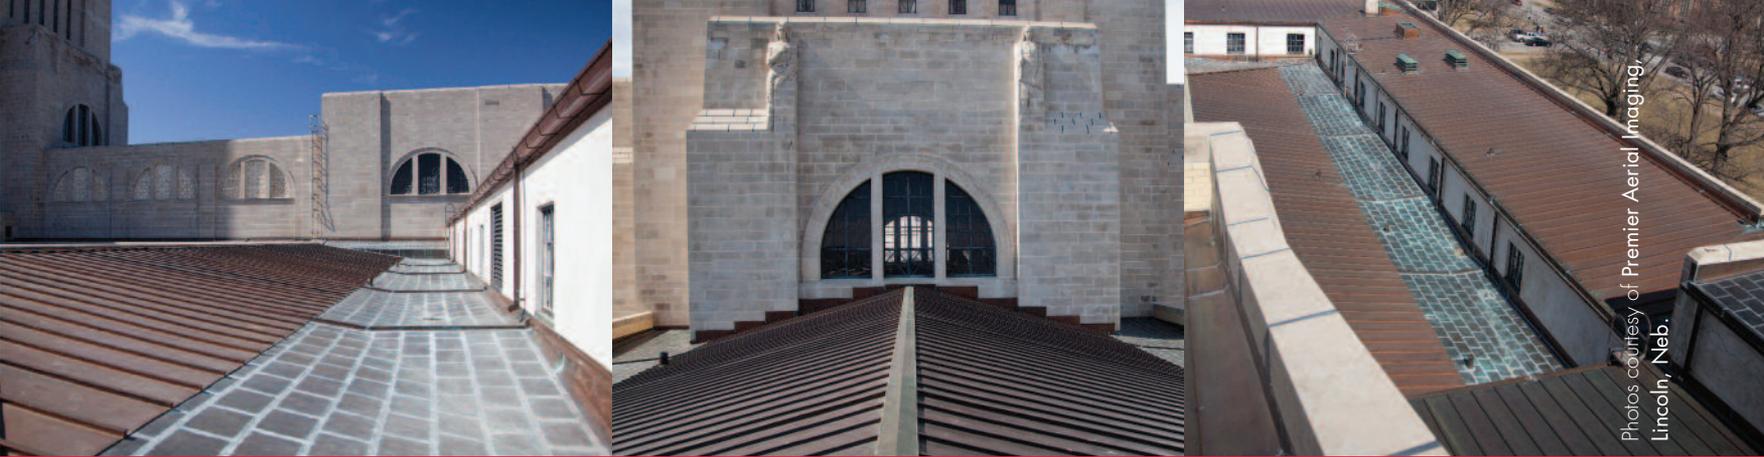
Midland Engineering fabricated and installed 20-ounce batten-seam and soldered flat-seam copper panels on the building's four quadrants, each of which has four to five roof areas at varying levels.

Workers then installed 2x4 sleepers anchored through the gypsum deck and 5/8-inch-thick plywood decking, followed by high-temperature underlayment and red rosin paper slip sheets. The slip sheets were tacked in place with staples and covered with 20-ounce batten-seam and soldered flat-seam copper the same day to avoid moisture damage to the red rosin.
